Test Report No: RJ4491-REV 1 **Original Issue Date: May 3, 2016**
Revised issue Date: May 31, 2016

SAMPLE ID: EasyTrim wall cladding system with Alucoil LARSON ACM 4-mm thick Fire Rated (FR) and 4-mm thick Polyethylene (PE) core panels.

TEST REQUESTED: ASTM E330-14 *Standard Test Method for Structural Performance of Exterior Windows, Doors, Skylights and Curtain Walls by Uniform Static Air Pressure.*

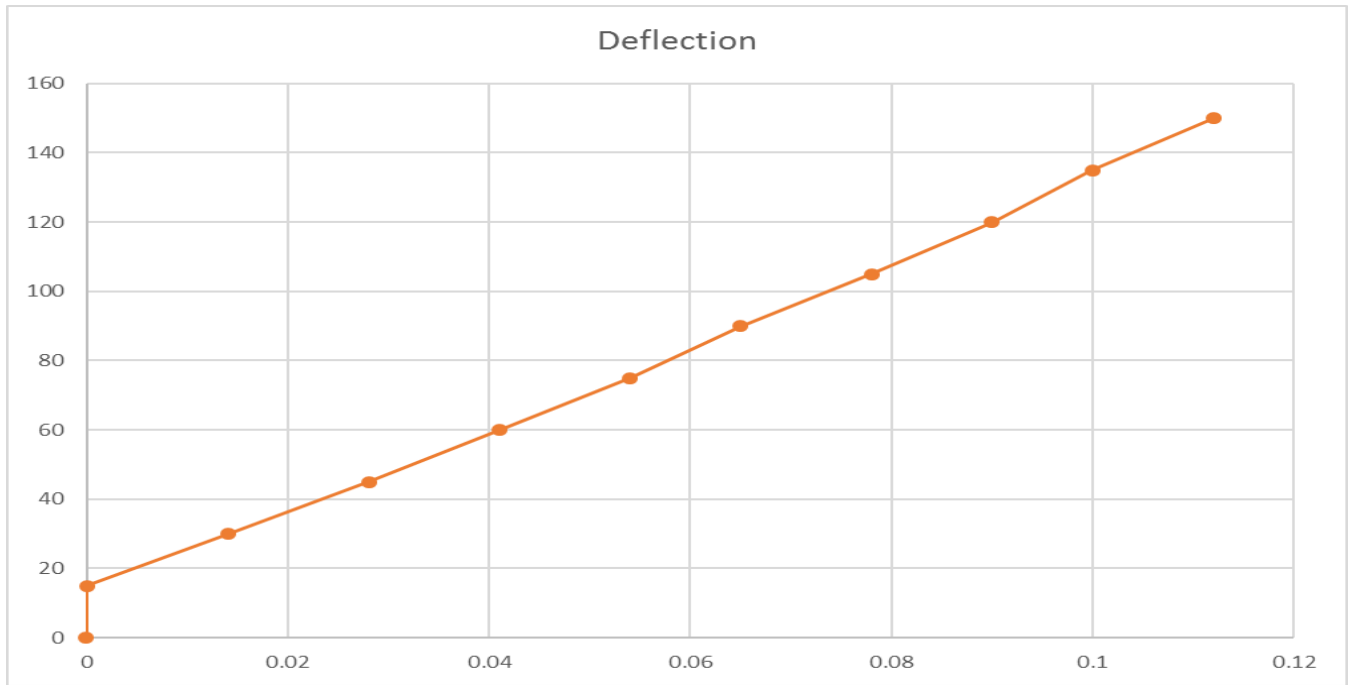
Assembly 1-Test 1 Load-Deflection Graph: 4' x 8' 4mm LARSON PE ACP with EASYTRIM ALUMINUM EXTRUSION in Positive Load Direction

Test Assembly & Test No.	Load Direction	Load L/60 Midspan (psf)	Ultimate Load (psf)	Allowable Load ⁽¹⁾ (psf)	Comments/Mode of Failure
Assembly 1-Test 1	Positive	Not Applicable	N/A	N/A	Assembly deflection limiter restricted further deflection of panel, failure of system could not be achieved.
Assembly 1-Test 2 ⁽²⁾	Negative	18	76	38	PE core panel pulled out of back plate / top cap trim assembly at one side of the panel. Back plate / top cap trim assembly remained intact. See photograph #5
Assembly 1-Test 3	Negative	18	97	49	PE core panel pulled out of back plate / top cap trim assembly at one side of the panel. Back plate / top cap trim assembly remained intact. See photograph #5
Assembly 1-Test 4	Negative	19	77	39	PE core panel pulled out of back plate / top cap trim assembly at one side of the panel. Back plate / top cap trim assembly remained intact. See photograph #5
Average		18	83	42	
Standard Deviation		1	12	6

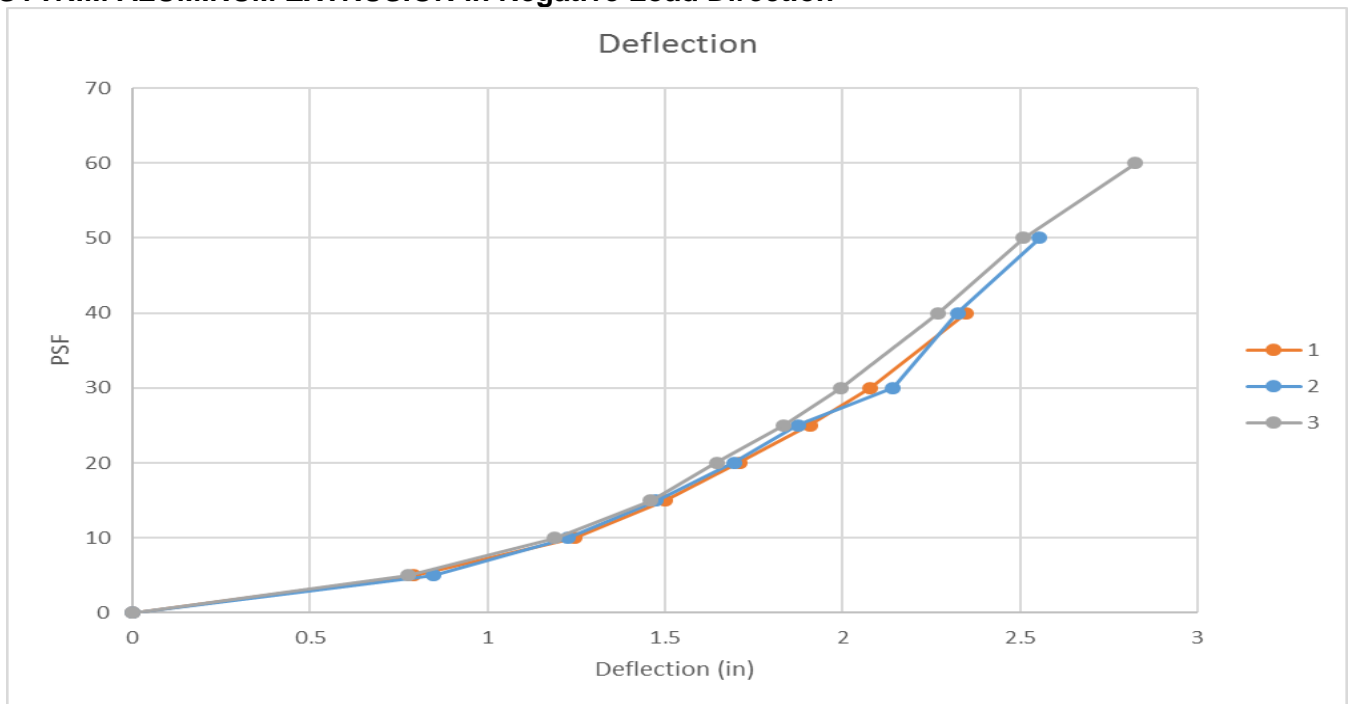
Assembly 1-Test Nos. 2 through 4 Load-Deflection Graph: 4' x 8' 4mm LARSON PE ACP with EASYTRIM ALUMINUM EXTRUSION in Negative Load Direction

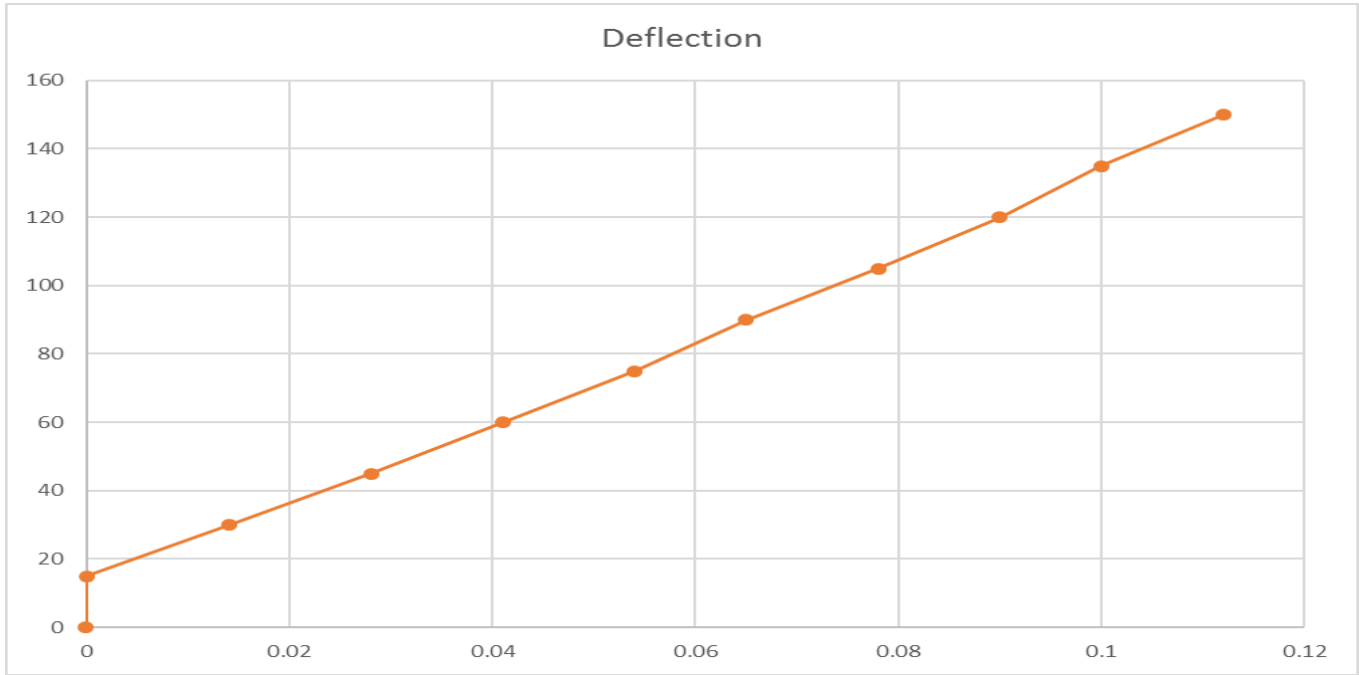
Assembly 2-Test 1 Load-Deflection Graph: 4' x 8' 4mm LARSON FR ACP with EASYTRIM ALUMINUM EXTRUSION in Positive Load Direction

Test Assembly & Test No.	Load Direction	Load L/60 Midspan (psf)	Ultimate Load (psf)	Allowable Load ¹ (psf)	Mode of Failure
Assembly 2-Test 1	Positive	Not Applicable	N/A	N/A	Assembly deflection limiter restricted further deflection of panel, failure of system could not be achieved.
Assembly 2-Test 2 ²	Negative	21	85	43	FR core panel pulled out of back plate / top cap trim assembly at one side of the panel. Back plate / top cap trim assembly remained intact. See photograph #5
Assembly 2-Test 3	Negative	20	85	43	FR core panel pulled out of back plate / top cap trim assembly at one side of the panel. Back plate / top cap trim assembly remained intact. See photograph #5
Assembly 2-Test 4	Negative	20	91	46	FR core panel pulled out of back plate / top cap trim assembly at one side of the panel. Back plate / top cap trim assembly remained intact. See photograph #5
Average		20	85	43	
Standard Deviation		1	3	2

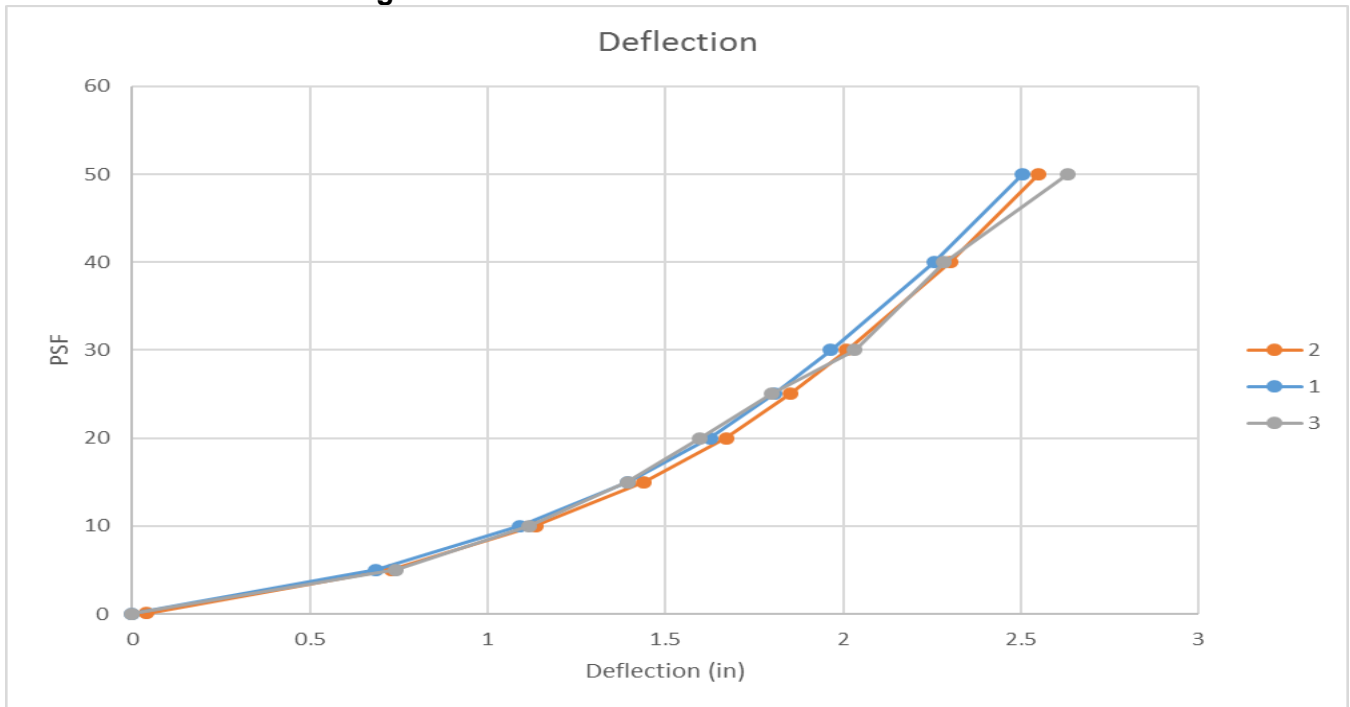
Assembly 2-Test No. 2 through 4 Load-Deflection Graph: 4' x 8' 4mm LARSON FR ACP with EASYTRIM ALUMINUM EXTRUSION in Negative Load Direction

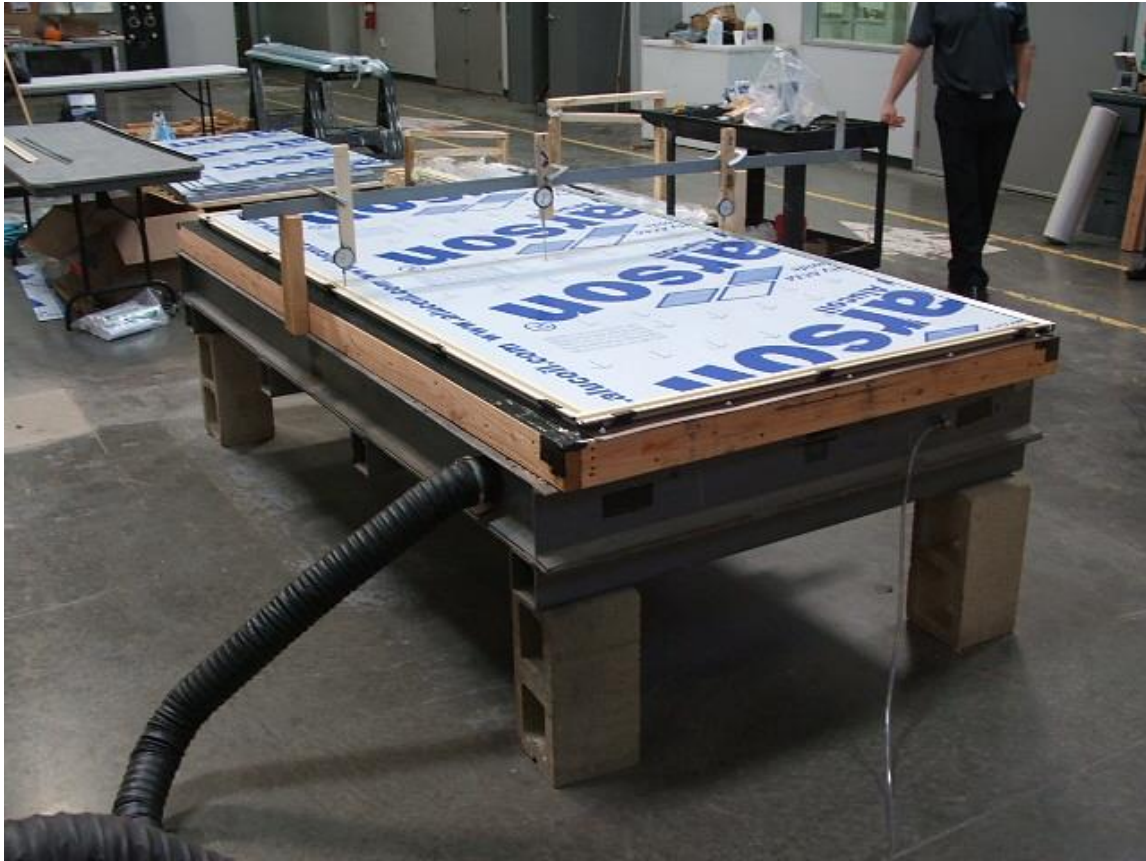
Photograph No.1
Negative Uniform Load Test Set-up

The EasyTrim aluminum T5 Grade T6063 aluminum extrusions described below was fastened to an open 4- by 8-ft wood frame constructed of nominal 2 x 4 inch Douglas-fir No.1 lumber that was placed and sealed on top of the perimeter of our steel test chamber shown in Photo 1 in Appendix A of this report. The extrusions were fastened to the wood frame with #8 coarse-thread wood screws of 3-inch length and spaced at 6 inches on center. Note that the wood screws and wood frame may or may not be representative of actual field installation other than to fix the extrusions for the purpose of the testing such that failure of the system will occur other than the extrusion fastening to a member or substrate (in this testing, the member would be the wood frame). We anticipate the limiting design of the system is the ACP panel connection to the extrusions as confirmed by the testing as the mode of failure for the rated allowable uniform load capacity.

A 6-mil polyethylene film was draped over the test assembly and sealed to the steel chamber for uniform load application by vacuum pressure applied to the steel chamber. When the vacuum pressure is applied, the 6-mil polyethylene that is applied over the test assembly induces a uniform load over the exterior side of the test assembly to create a positive direction loading, similar to wind loading to the face of a wall panel. For negative load direction, the test assembly was flipped on the other side with the 6-mil polyethylene sheet placed over the interior face of the exterior cladding system under evaluation.

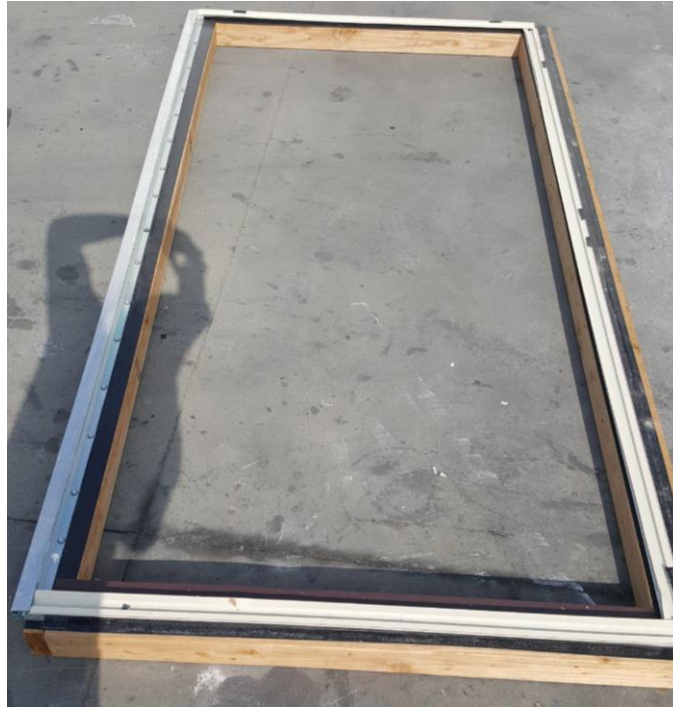
Photograph No.2

Test Frame with The EasyTrim Extrusion Assembly installed after ACP Test Panel was removed after test.

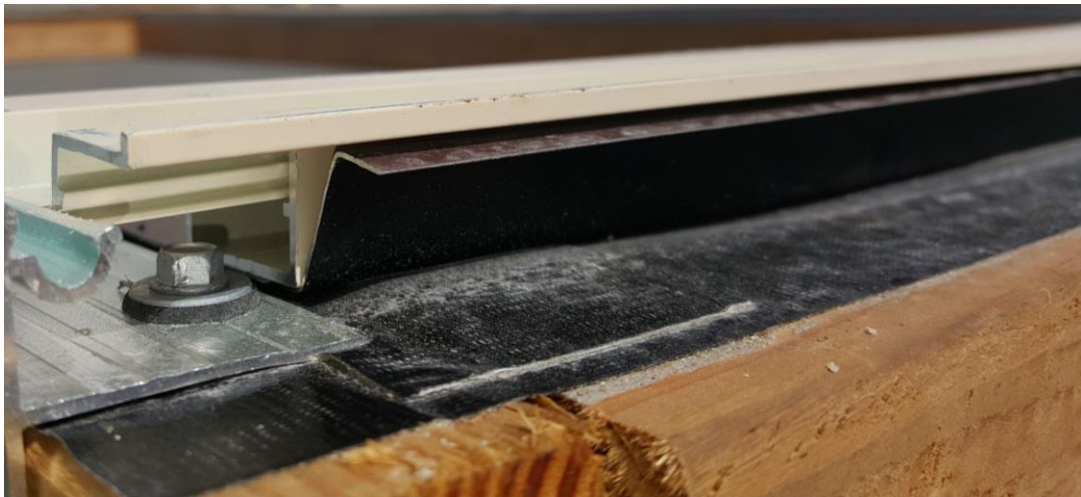
Photograph No.3

QP-3 Horizontal Extrusion Profile Used with QP-90-1, Used to Simulate Horizontal Termination of Assembly (1 Edge of Assembly), After test.

Each EasyTrim wall cladding test assembly consisted of the EasyTrim Extrusions QP-90-1 and QP-90-2 (see *diagram 3 and 4 and photograph 4 in Appendix of this report*) which were installed along two boundaries of the wooden frame, The EasyTrim QP-3 Horizontal Extrusion in conjunction with QP-90-1 along one frame boundary (see *diagram 1 and 4 and 3 and photograph 3*) and at the 4th wood frame boundary consisted of the EasyTrim QP-4 and QP-5 Inner and Outer Corner extrusions (see *diagram 2 and 4 and photograph 2*). All extrusions as mentioned were installed to secure the 4' X 8' x 4-mm thick ACP Panels by friction-fit, as representative of the typical field installation. At adjacent friction-fit clamping areas of the EasyTrim Wall Cladding system for connection of multiple ACP Panels, a ¾-inch wide strip of the 4-mm ACP Panel was cut and installed in the EasyTrim Extrusion assemblies (QP-90-1, QP-90-2, QP-4, QP-5 Inner and Outer Corner) to fill the space and represent the adjoining ACP Panel thickness (see *Diagram 4 and photograph 4*).

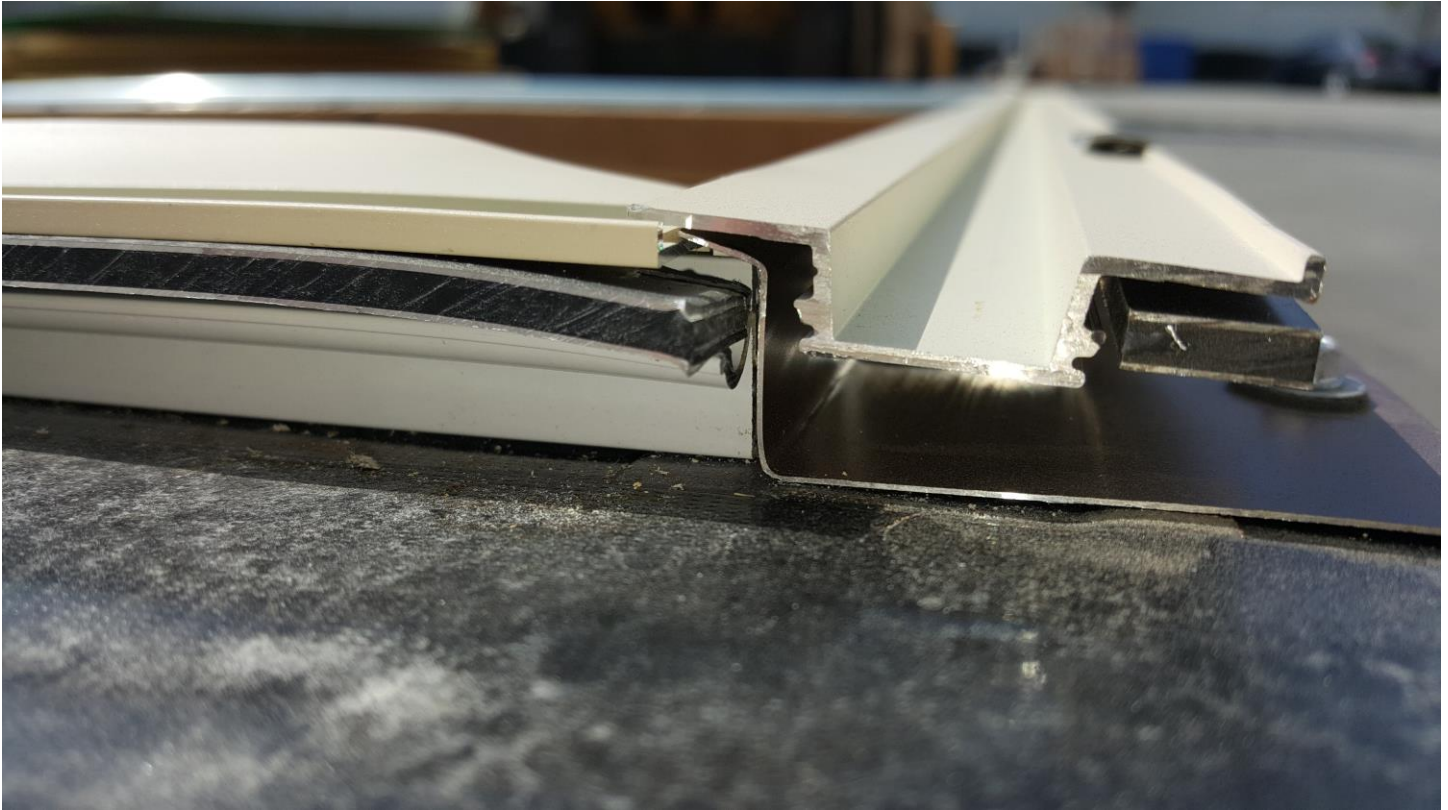
Photograph No.4

EasyTrim Extrusions QP-90-1 and QP-90-2 used along 2 edges of the Test Frame with 3/4" Wide Strip of ACP Panel installed on Adjacent Edge to simulate Typical Field Installation after Test.

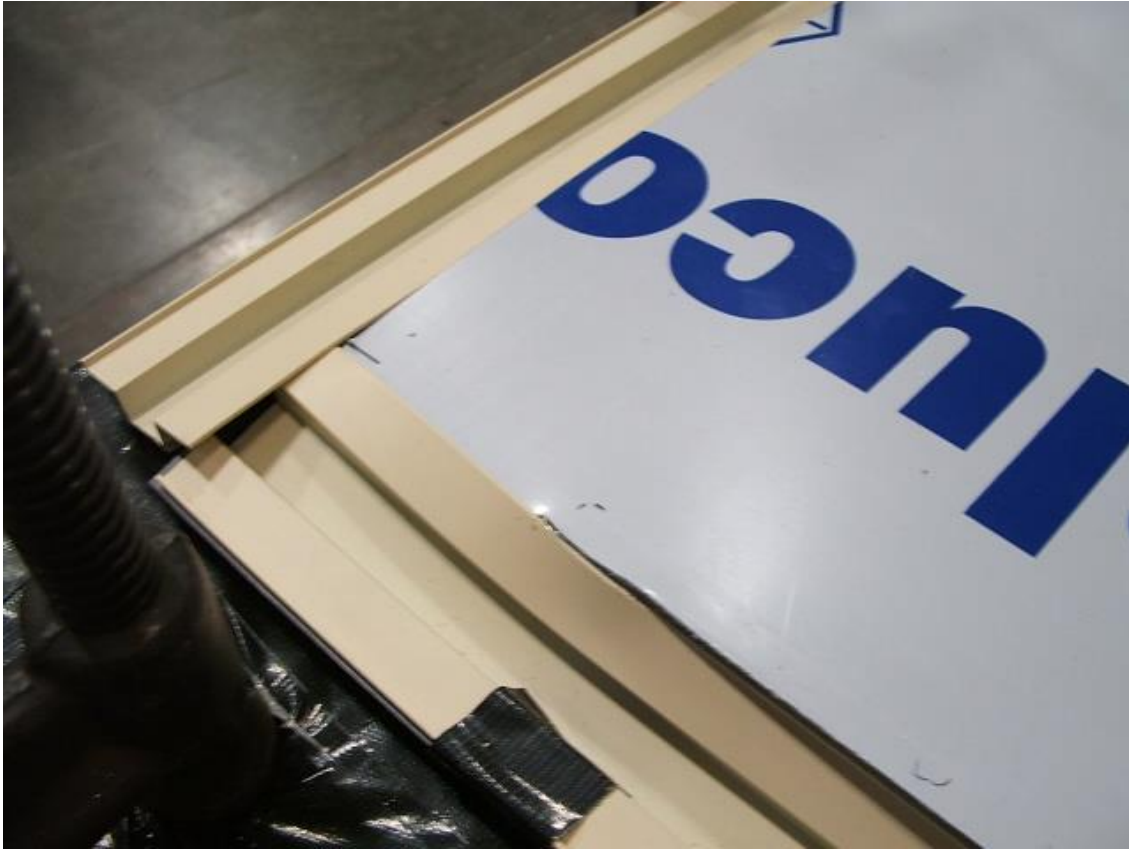
Photograph No.5

Typical results of negative load tests Panel separated from back plate / top cap trim assembly at one side of the panel. Back plate / top cap trim assembly remained intact.

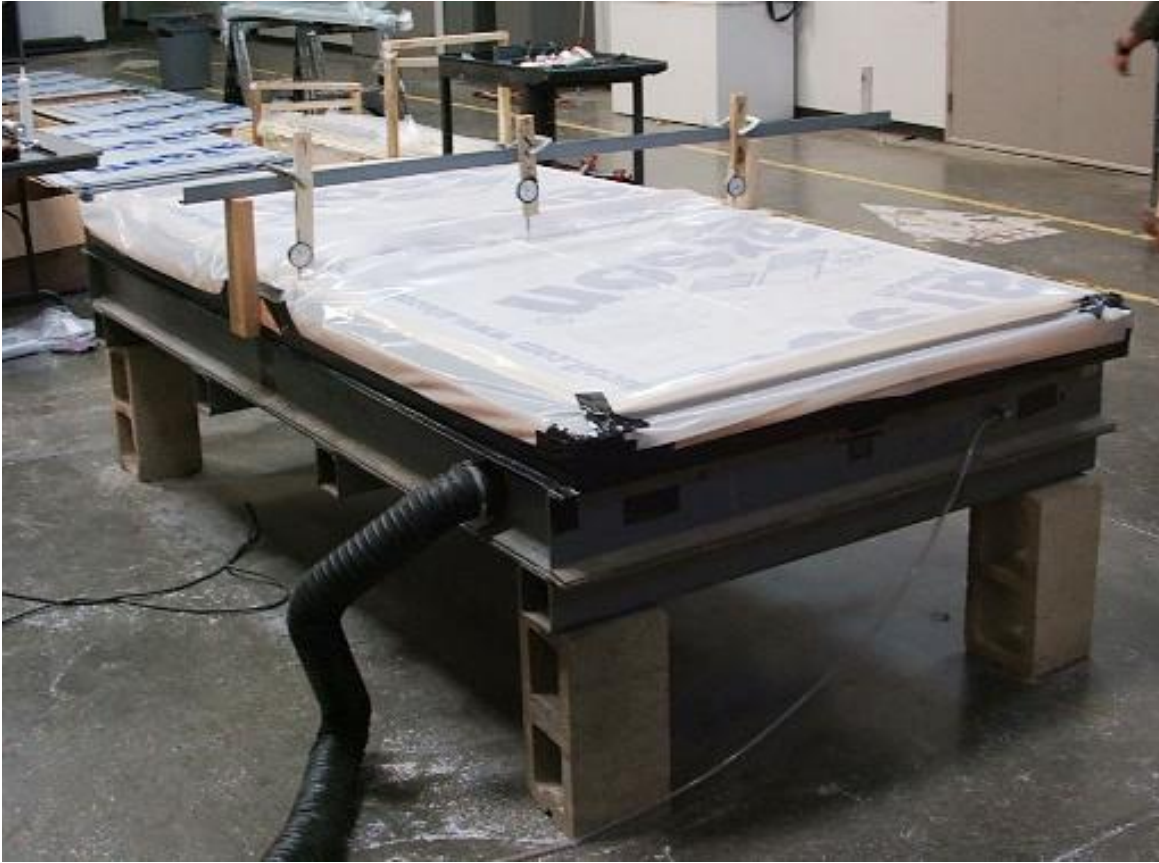
Photograph No.6
Positive Uniform Load Test Set-up

A single test assembly was loaded in the positive pressure direction, followed by testing of another single assembly in the negative pressure direction to determine the weaker direction of the panel assembly. Once determined, two additional cladding assemblies were tested in the weaker load direction to fulfill the three replicate sample set. Photographs and diagrams of the test set up is provided in Appendix A of this report.

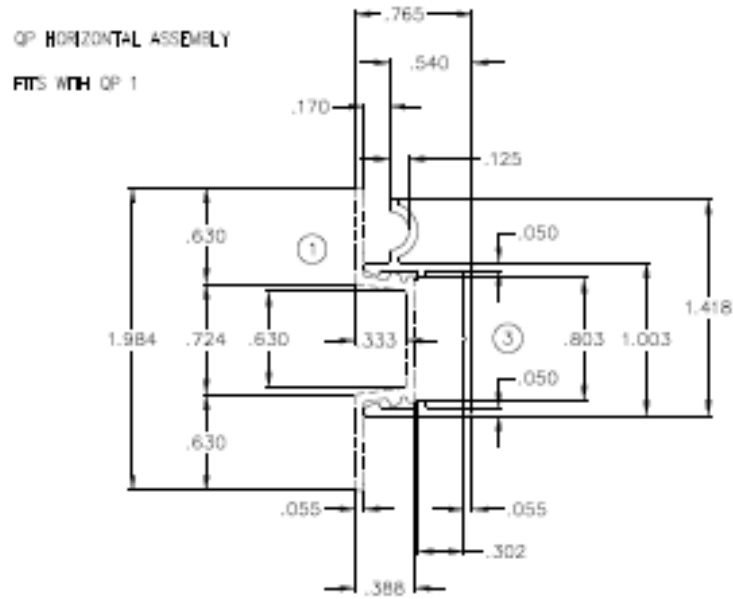
Diagram No.1
QP-3 Horizontal Extrusion Profile Used for Horizontal End Installations

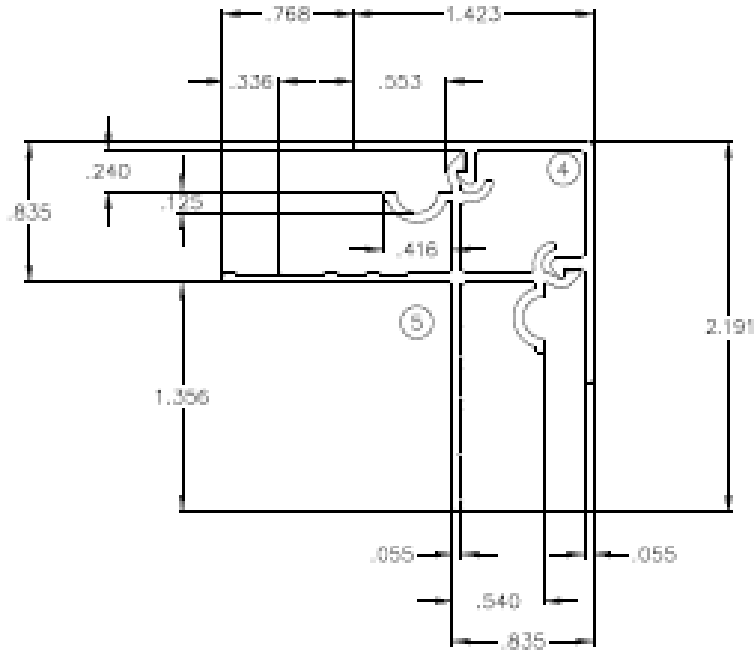
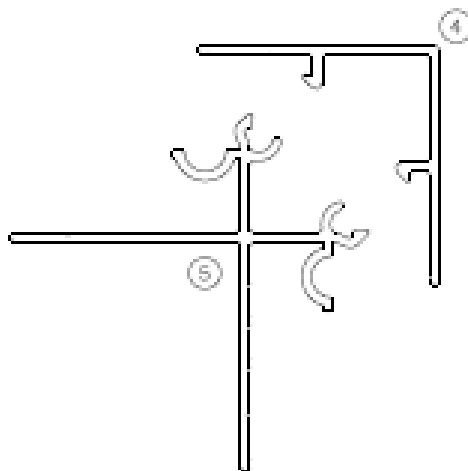
Diagram No.2
QP-4 and QP-5 Inner and Outer Corner Assembly Extrusion Profile Used in Test Assembly

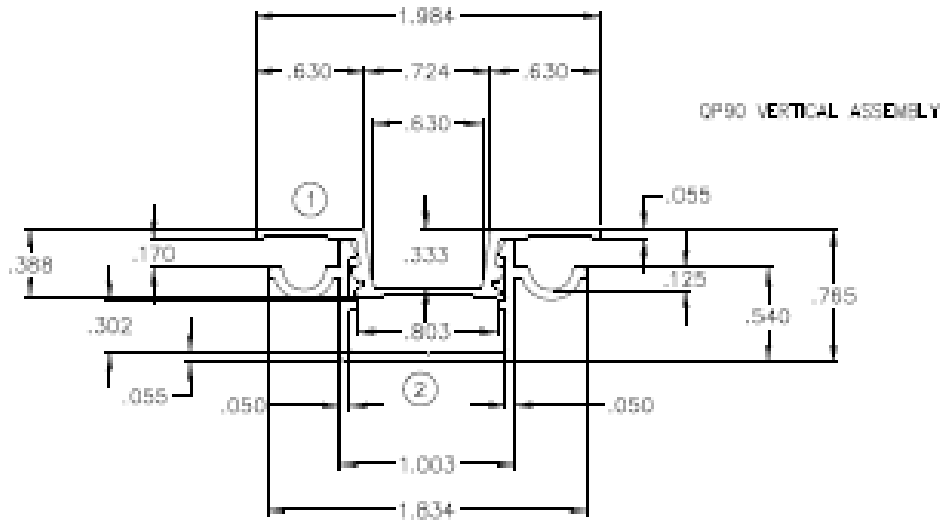
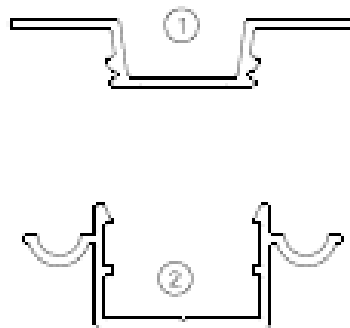
Diagram No.3
 QP-90-1 and QP-90-2 Assembly Extrusion Profile Used in Test Assembly

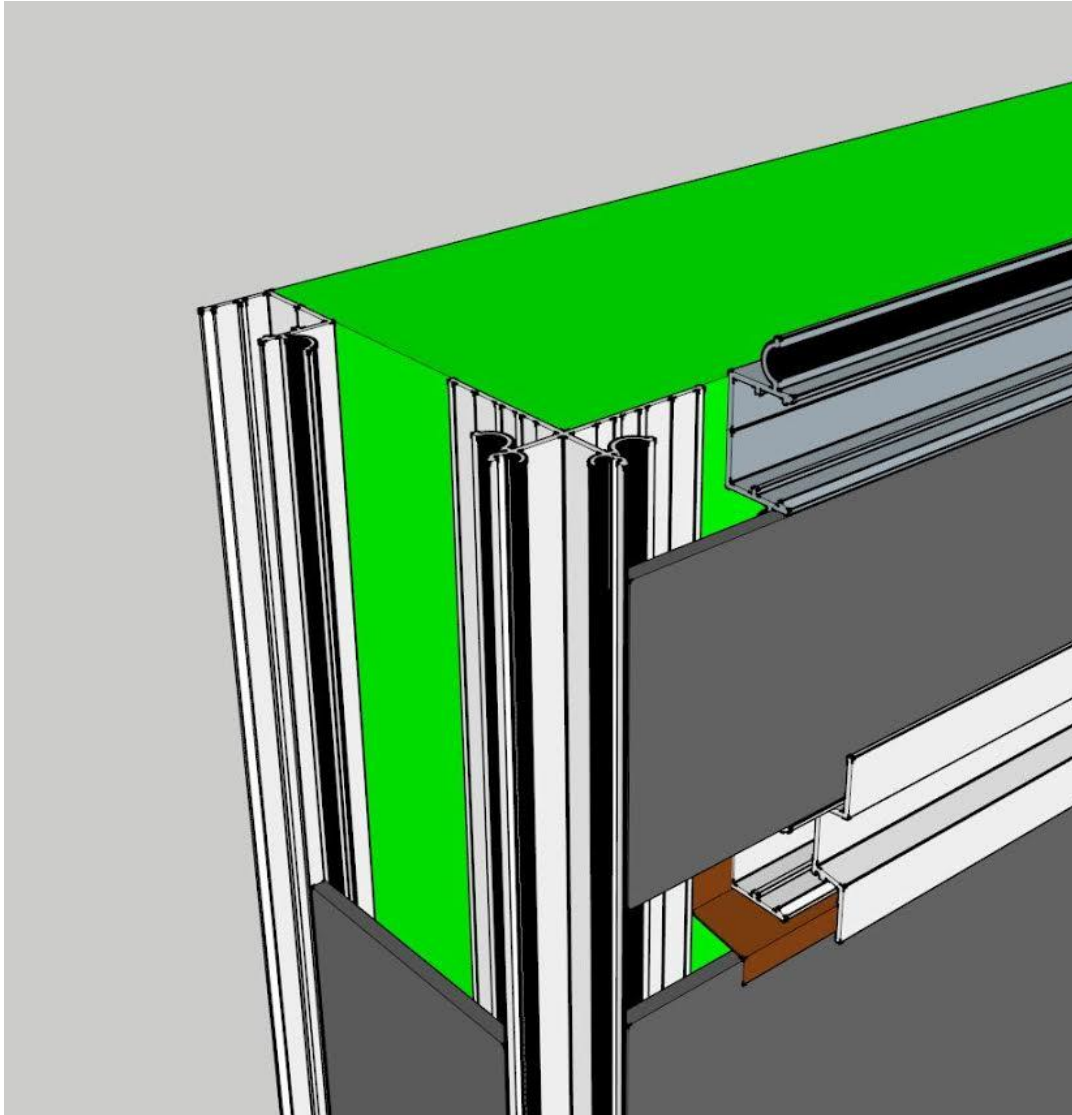
Diagram No.4
Assembly Drawing of All Components used in a typical Field Installation
